POLARIS
The Way Out.

TECHNICAL SERVICE BULLETIN

Bulletin Number: S-06-10

SUBJECT: 2007 FS / FST Oil Pump Elbow Nozzle Fastener Torque

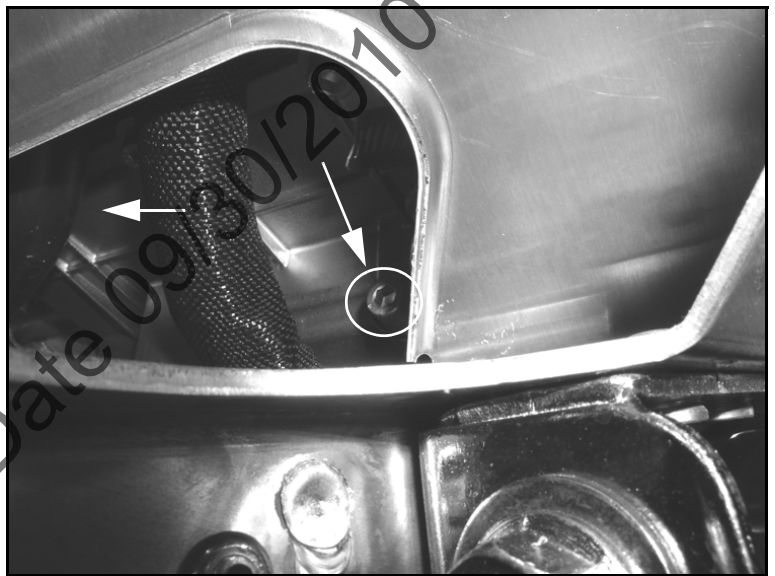
Polaris has determined that the torque applied to the fastener securing the oil pump elbow nozzle to the crankcase may be inadequate and must be re-torqued. If the fastener were to become loose and fall out, the elbow nozzle may fall out of the crankcase causing an immediate loss of engine oil, resulting in severe engine damage.

7. Use a flashlight to locate the fastener. Move the wiring harness out of the way if obstructing view.
